GEOTECHNICAL CONSTRUCTION SERVICES

McFarland Retaining Wall Collapse

Harrisburg, PA

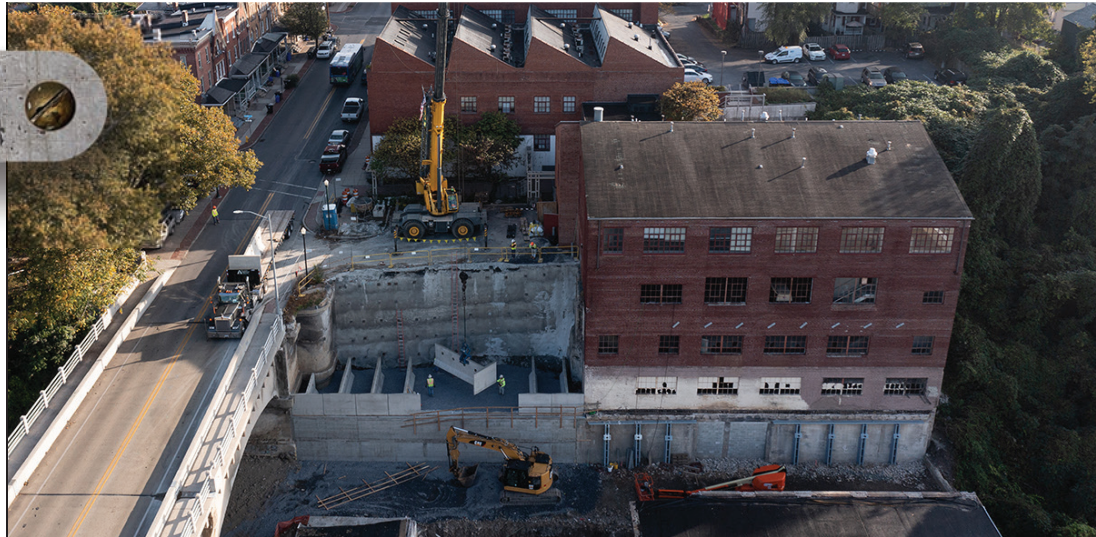
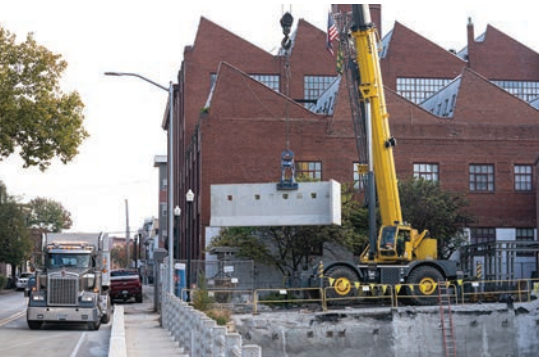
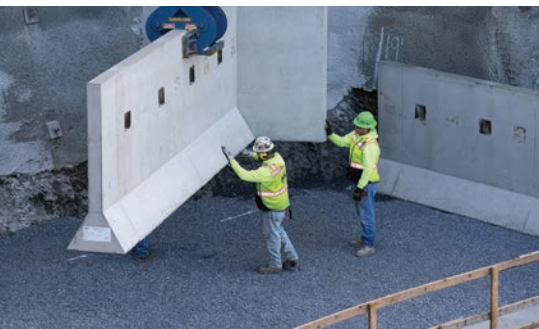
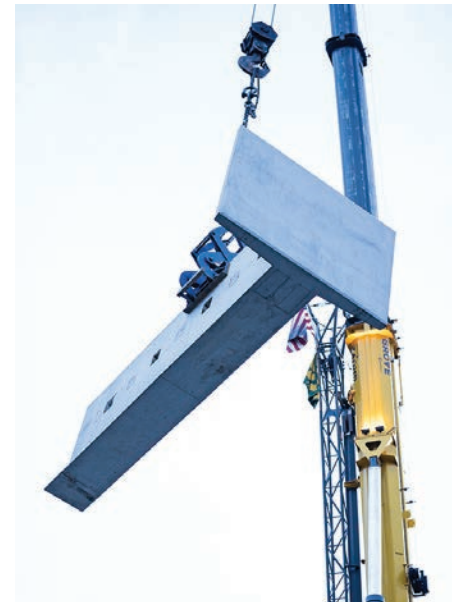
The McFarland Retaining Wall Collapse project consisted of site stabilization, remediation, and repairs. A 100+ year old wall located adjacent to the McFarland Apartment Building collapsed onto the Howard Tire Building located directly below the wall and the McFarland Building. Soil nails and shotcrete were installed to stabilize the slope so a new Gravix Retaining wall could be constructed. The Gravix wall panels and barrier were manufactured by Atlantic American Precast. Permanent Tieback anchors were installed inside of the parking garage of the building and at the exterior base of the McFarland building to anchor the structure to the rock and prevent and additional failures. Thru-wall bracing assemblies were also utilized to support the building. An abandoned building located between the McFarland and Howard Tire building was demolished and a 30 mil HDPE, clay liner and rock lined swale were installed to help improve drainage at the base of the wall and building. A temporary roof was installed on the Howard Tire building to provide security from the weather and thieves.

- Site Stabilization: Soil Nails and Shotcrete
- Building Stabilization: Permanent Tiebacks and Thru-Wall Bracing Assemblies
- Retaining Wall: Gravix Retaining Wall

- 65 EA Soil Nails
- 2,080 LF of Soil Nails: 15' - 45' in length
- 1,550 SF of Shotcrete Wall
- 11 EA of PTI Class 1 Corrosion Protection Tieback Anchors: #10 bar, 25' overall length
- 16 EA of Thru-Wall Bracing Assemblies Galvanized L4x4x5/16
- 1,931 SF of Gravix Retaining Wal
- 72 LF of Barrier on top of Gravix Retaining Wall
- 260 CY Reinforced Concrete Foundation for the Gravix Wall
